Water-Supply Paper 994

**CLOUDBURST FLOODS IN UTAH**  
**1850-1938**

By  
**RALF R. WOOLLEY**

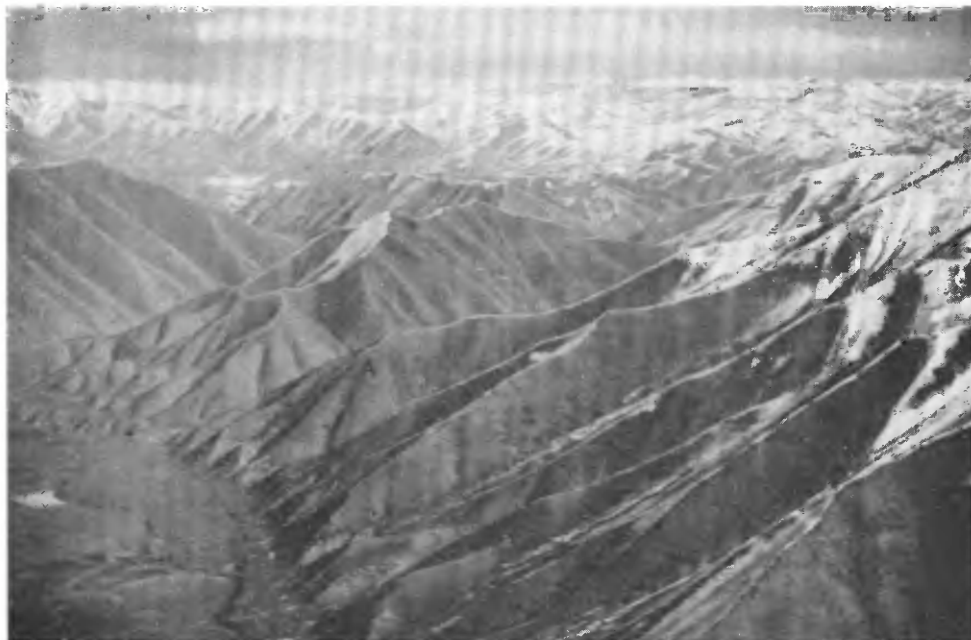
4. WASATCH RANGE EAST OF SPRINGVILLE.

Shows an unglaciated and maturely dissected part of the western margin of the range. Note the roughly triangular, gully-scarred fault-facets (A) steeply notched on their lower margins by wave-cut cliffs aligned along an ancient beach of Lake Bonneville. A recent fault scarp associated with the Wasatch fault zone appears as a dark shadow at left of beach. Note accordant summit levels of the range in the background where it merges with the Uinta Mountains on the horizon. View looking northeastward. Air photo by R. E. Marsell.

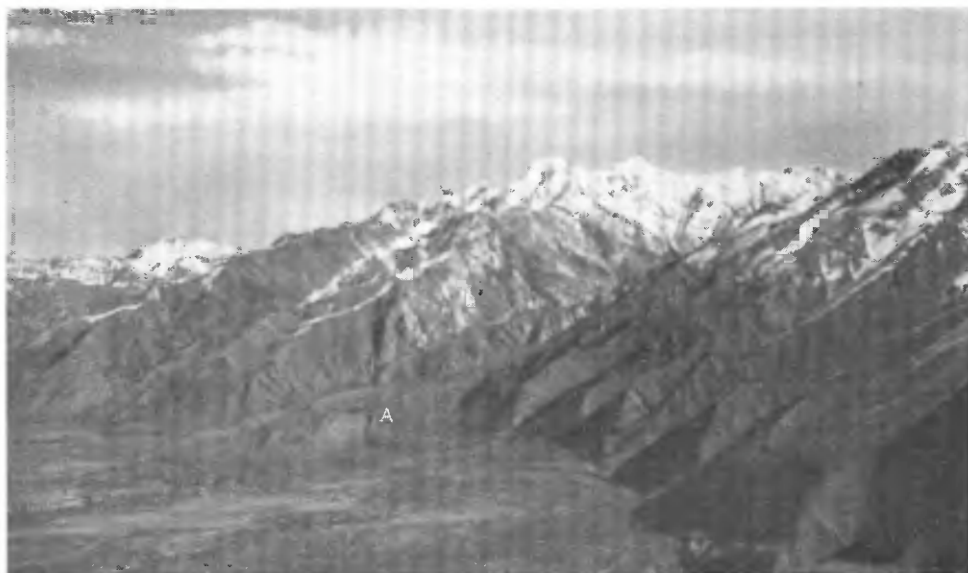
B. WASATCH RANGE SOUTHEAST OF SALT LAKE CITY.

Shows horseshoe-shaped glacial moraine 700 feet high at mouth of Bell Canyon (lower left of center). Note sharply truncated ends of ridges, these triangular fault-facets being faintly notched by a shore terrace of Lake Bonneville in lower right corner of photograph. Recent fault scarp, plainly shown below (west of) these facets, has dislocated the moraines at A. View looking northeastward. Air photo by R. E. Marsell.

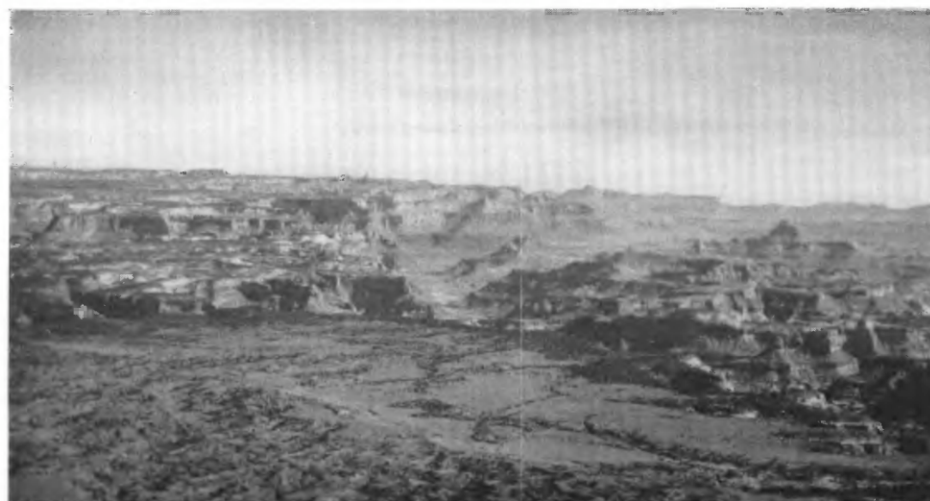
B. A TYPICAL LANDSCAPE IN THE CANYON LANDS.

San Rafael district of the Canyon Lands section of the Colorado Plateau province. Note labyrinth of cliff-walled gorges separated by flat-topped benches or pinnacle-capped ridges, with isolated buttes and mesas. Book Cliffs erosional escarpment dimly visible on the horizon. View looking southeastward. Air photo by R. E. Marsell.

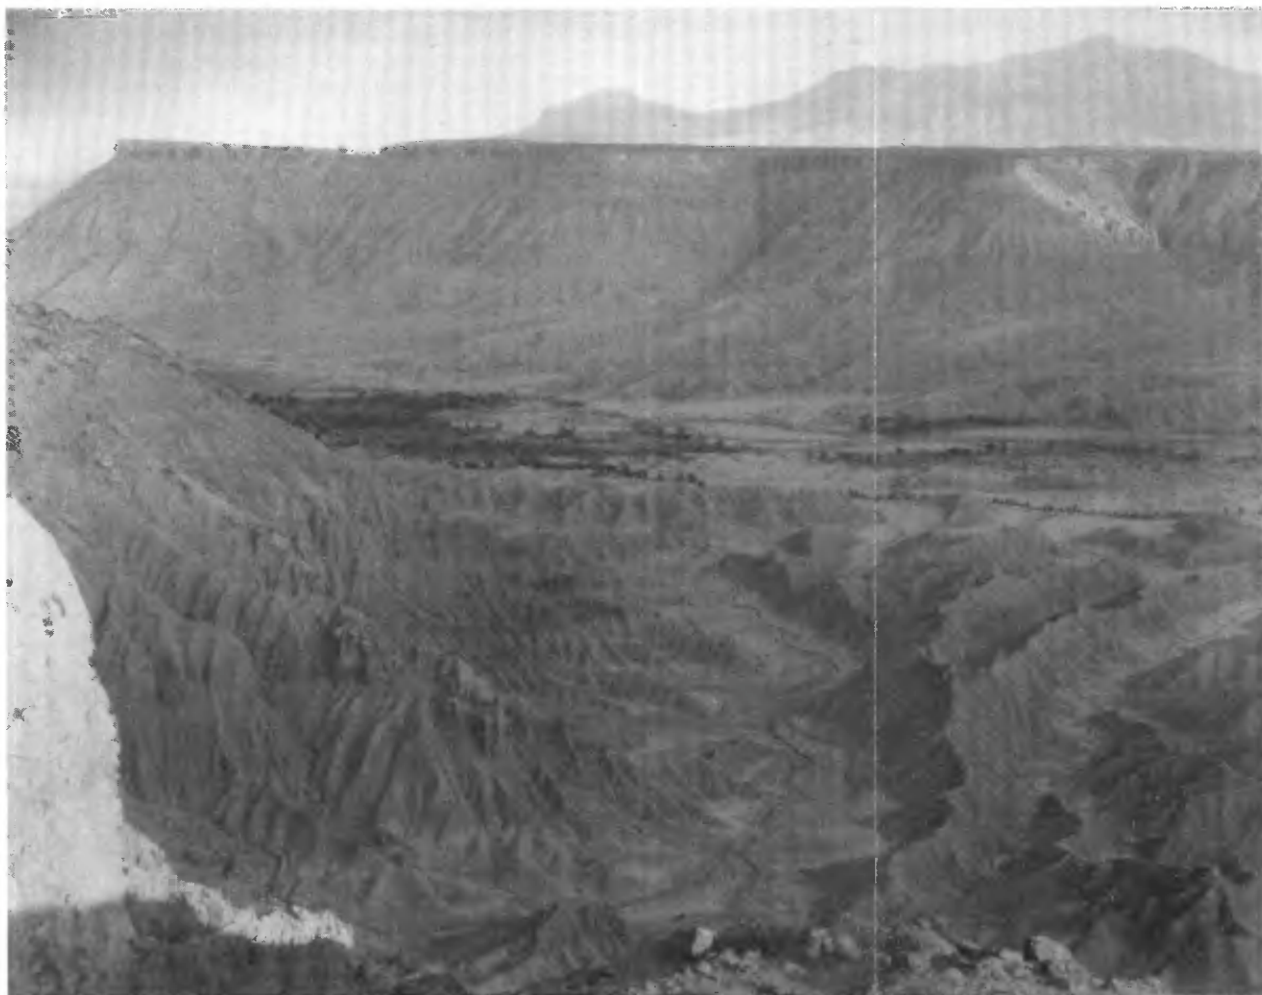
A. MOUNT ELLEN, HENRY MOUNTAINS.

Shows northernmost of the isolated laccolithic mountain groups along the western margin of the Canyon Lands. Note typical badland topography developed on the soft mudstones and shales of the Moenkopi formation. Bench in middle distance is capped by resistant Shinarump sandstone. Photo by J. E. Broadus.

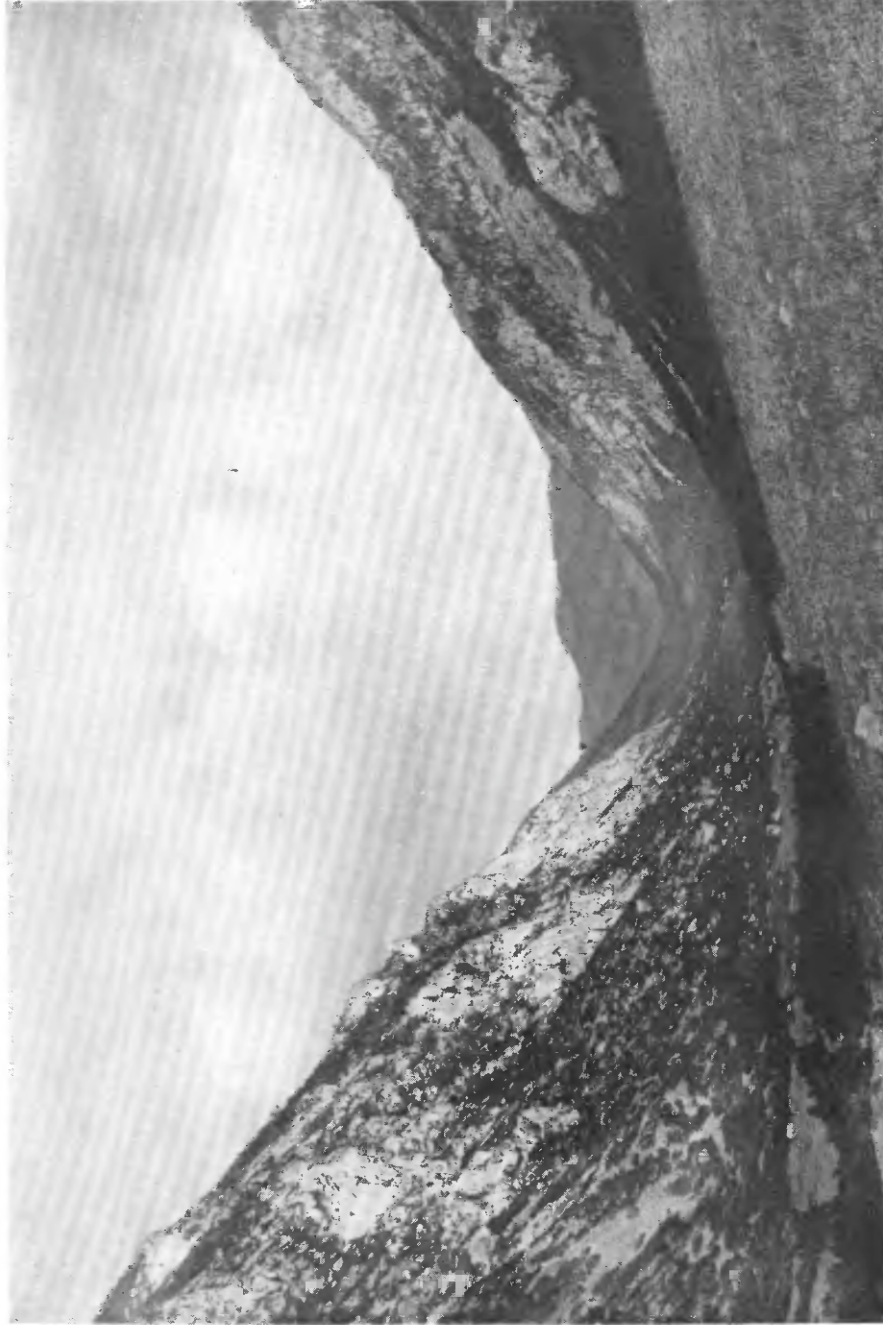
LITTLE COTTONWOOD CANYON, WASATCH RANGE.  
Note troughlike U-shaped profile of glaciated mountain valley.

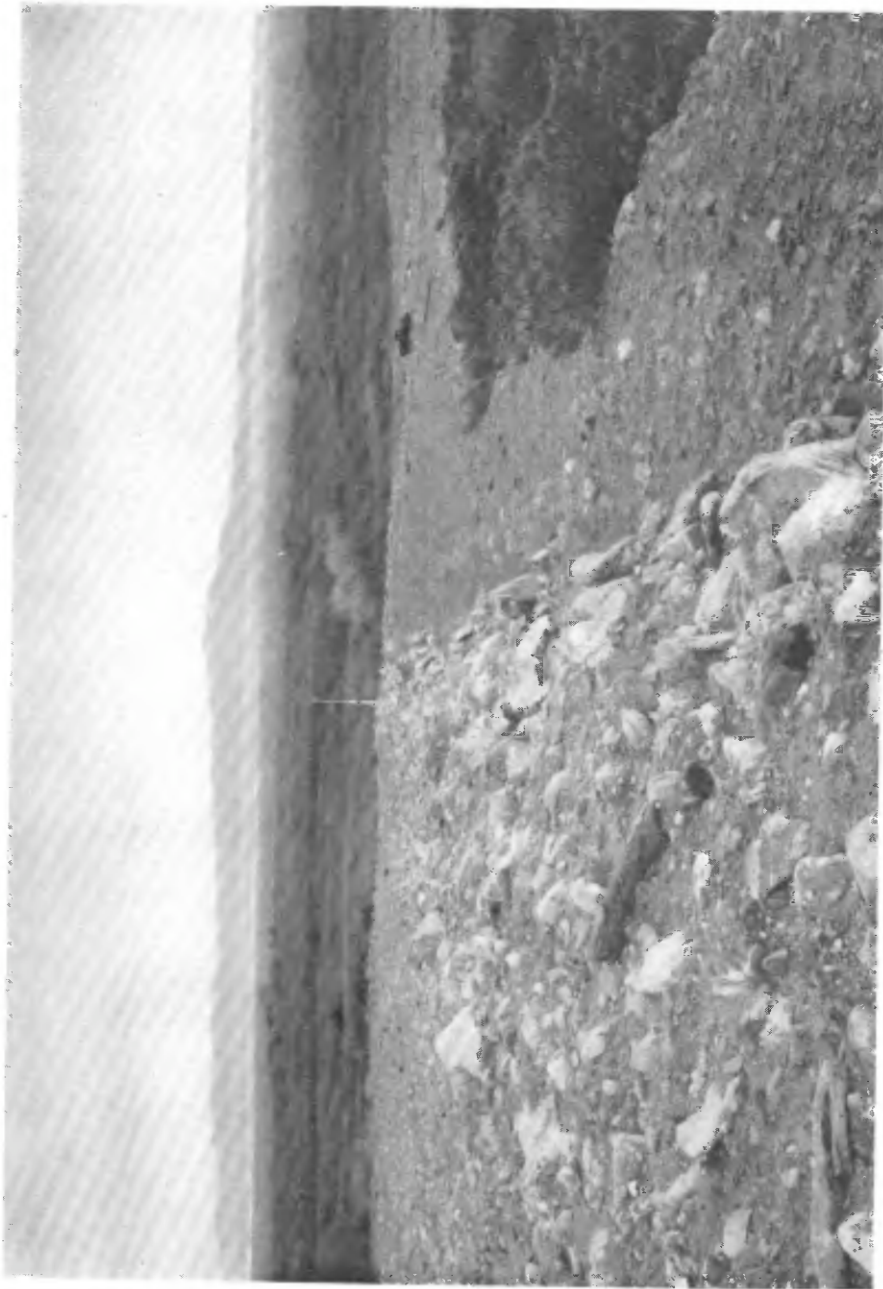
TWO SUCCESSIVE MUDELOWS NEAR LAYTON, DAVIS COUNTY.
